Memo

Re: Community Update #7 (Week of October 9, 2023)
Cypher/E Street Improvement Project
South Boston, Massachusetts
GEI Project No. 2302746

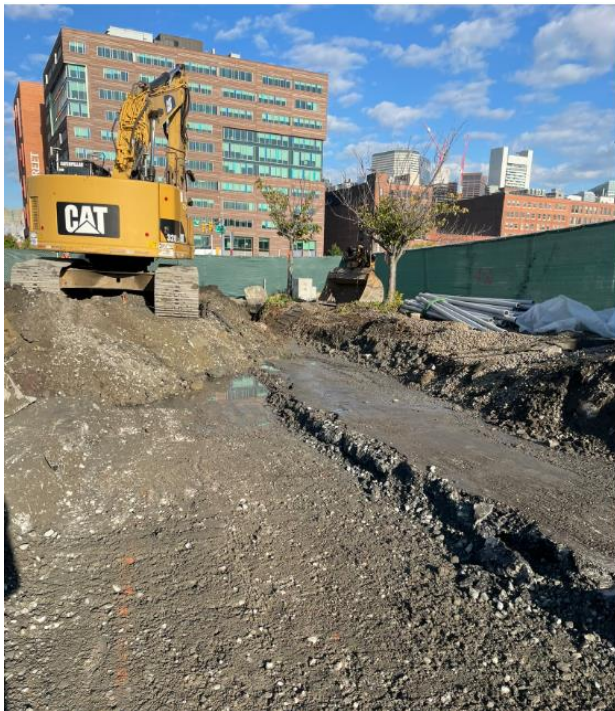
Moist soil in TSCA Area excavation

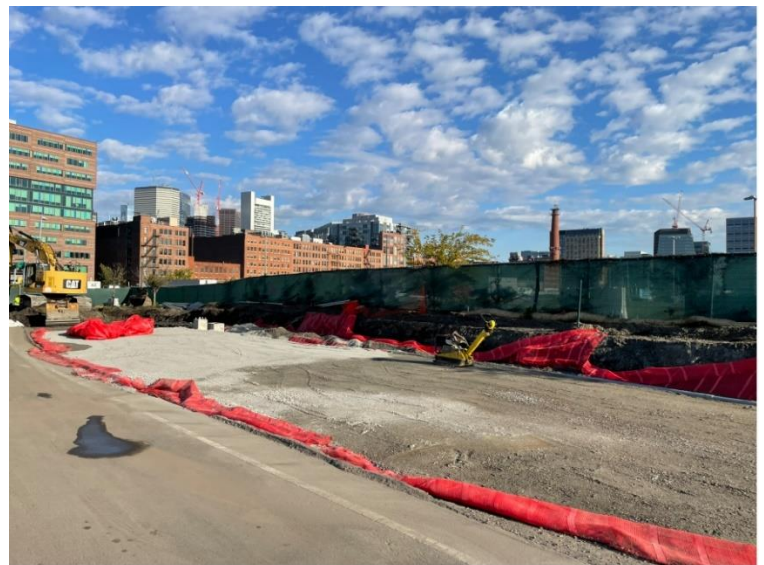
Soil in TSCA work zone was excavated. An orange ID marker was installed at the final subgrade elevation and backfilled with clean dense grade material (see photo log). No portion of the excavation was left uncovered. Dust control monitoring, watering, and sweeping was conducted. The soil excavated in the TSCA area was moist enough that it required minimal additional dust control measures (see photo log). Dust monitoring during excavation did not indicate additional action was required. Nine trucks of TSCA soil were shipped offsite each day on October 10 and 12, 2023.

Backfill with linear in TSCA area

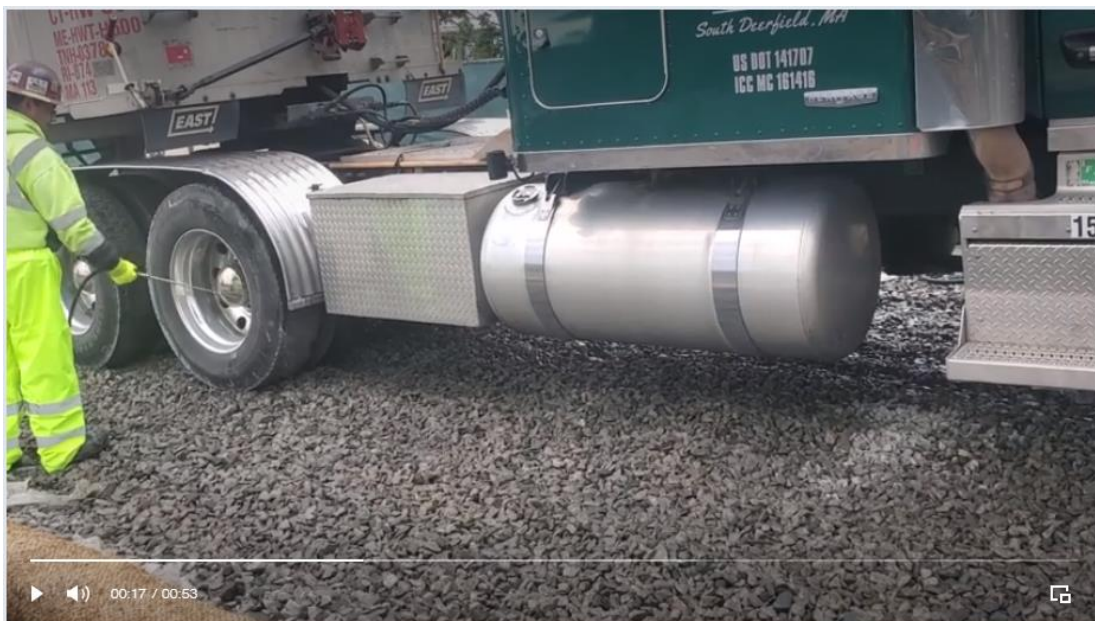
The trucks were decontaminated prior to leaving the site. Videos of the decontamination are in the photo log. First the front end of a truck, the cab and front trailer wheels, was positioned on the decontamination pad, sprayed with orange solve cleaner and water. Then the truck was moved forward to position the rear trailer axel over the decon pad which was cleaned. The trucks were covered inside the work fence and escorted offsite and instructed to turn left to the Bypass Road.

Watch video of front end of truck in decontamination wash pit

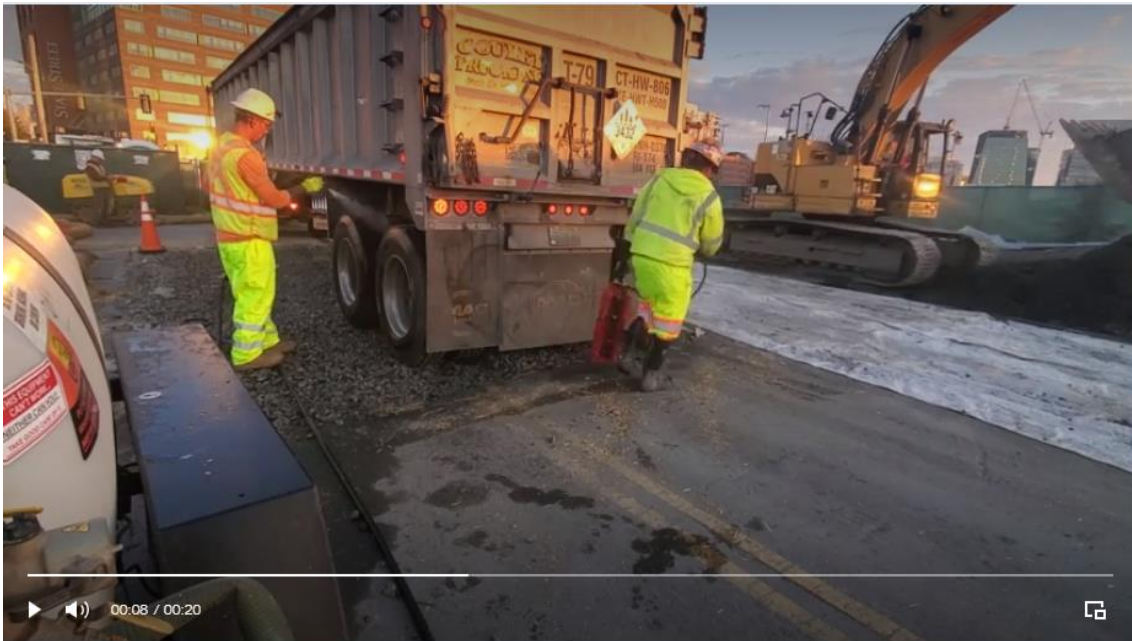
Watch video of back end of truck in decontamination wash pit

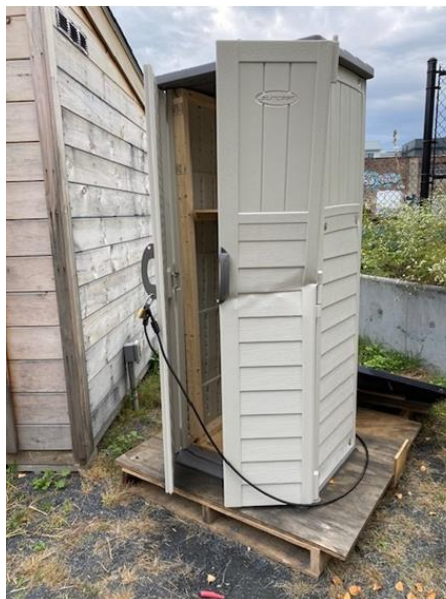
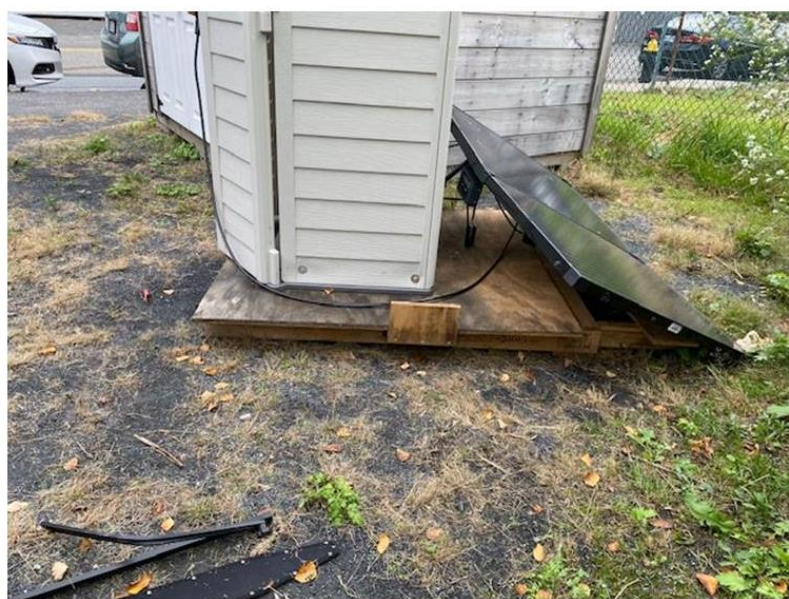
The dust monitor at Mahoney Park was stolen (photo log) overnight on October 9, 2023. Massport filed a police report. As a result of the theft, the dust monitors will be deployed daily at all three parks during the work week. Tetra Tech will place a monitor in each park at the beginning of the workday and remove it at the end of the workday. They will also be removing the solar panels and will rely on a battery pack for the monitors.

Vandalized dust monitoring sheds in Mahoney Park
