Memo

Re: Community Update #9 (Week of October 23, 2023)
Cypher/E Street Improvement Project
South Boston, Massachusetts
GEI Project No. 2302746

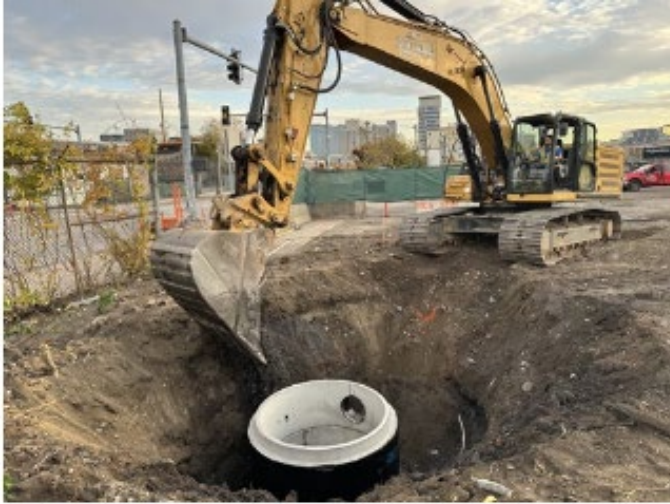
Catch basin in C to D Connector

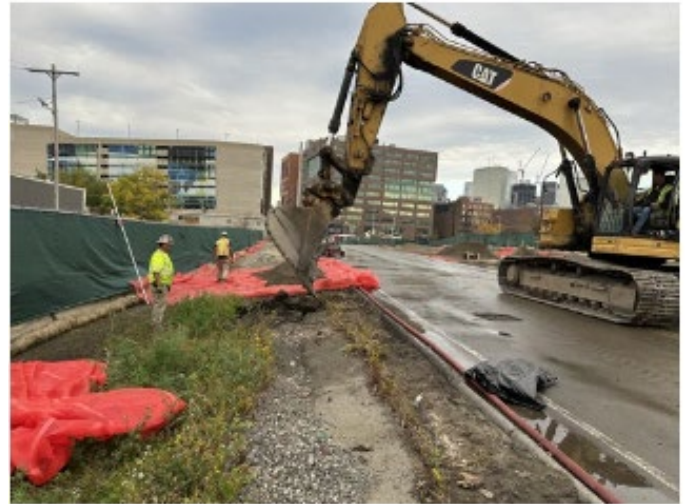
Continued placement of imported material on southern portion of TSCA area that did not require excavation. An orange ID marker was installed at the final subgrade elevation and backfilled (see photo log).

Placement of marker and linear on
South side of TSCA area

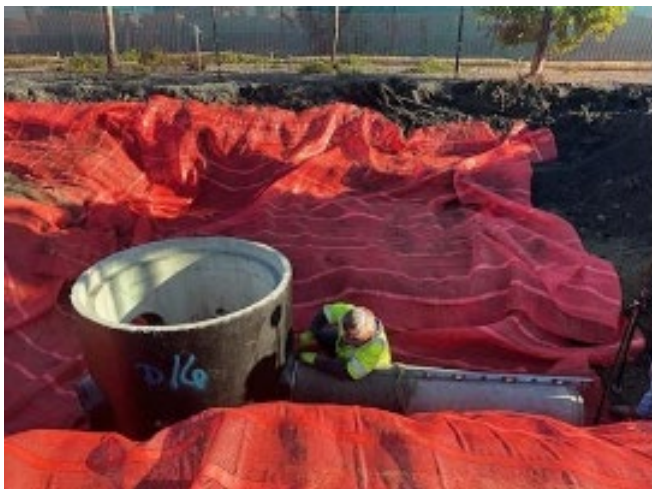
Manhole structures and drainage were installed in clean backfill above the marking layer (see photo log).

Catch basin in roadway in TSCA area over
marking layer

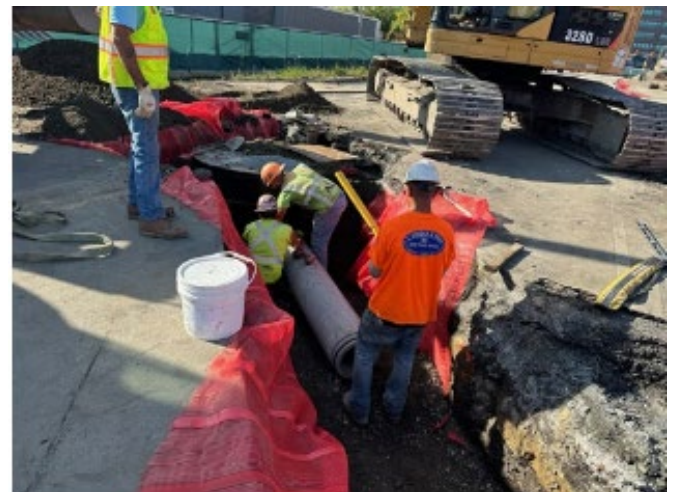
Drainage in roadway in TSCA area over
marking layer
